The use of porous alumina bioceramics to repair bone defects in the aspect of long-term success of hip arthroplasty

Marzena Lachowicz, PhD. DSc. Eng.¹✉, Ziemisław Stępniewski, Dr.², Monika Morawska-Kochman, MD, PhD³✉, Maciej Lachowicz, PhD. Eng.⁴✉

Orthopedic Reviews

Vol. 17, 2025

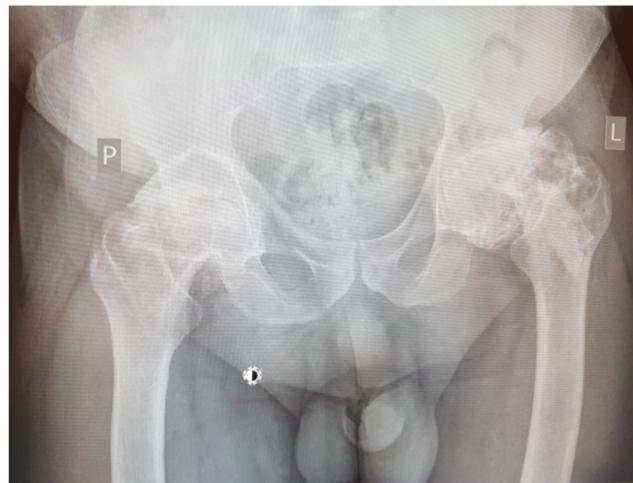
Figure 1. Preoperative plain radiographs show bilateral secondary coxarthrosis with ceramic bolts visible in the left intertrochanteric area.

A 35-year-old man suffering from necrosis of the femoral head of the left hip joint underwent surgical treatment consisting of drilling the necrotic head and filling the femoral neck with bioceramic elements (Fig. 1). The porous bioceramic material had the following chemical composition: 97% Al_2O_3 , 2.5% MgO , and 0.5% CaO .¹⁷ The manufactured material (open porosity, 70–80%) was characterised by external and internal pores with pore diameters between 100 and 800 μm . The outer and the inner pores were filled with healthy bone tissue adherent to the ceramic material. Bieńiek¹⁷ the material was used to fill bone cysts and postsurgical or trauma-related bone defects.

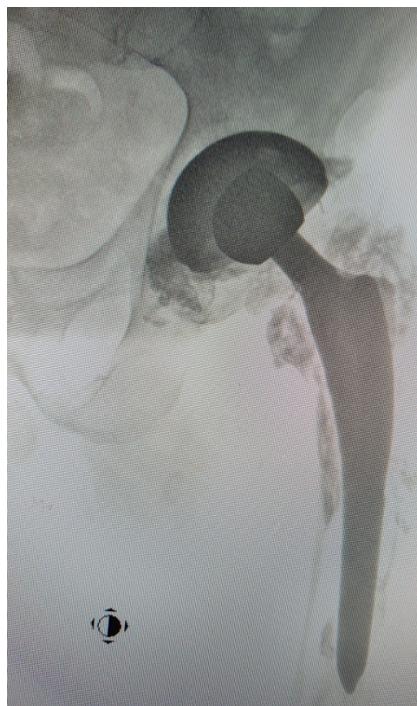
Figure 2. Radiographs before total revision

to have deformation of the metal head of the endoprosthesis, appearing in control X-rays with relatively minor changes in the thickness of the polyethylene (acetabular insert). The head deformation was accompanied by defects that were visible in the form of radiolucencies located in the third, closer to the femur and in the area of the lower pole of the acetabulum (Fig. 2). The patient reported increasing pain in the left hip joint (increasing with weight bearing), and therefore qualified for revision surgery. The examination revealed severe macroscopic deformation of the metal head of the endoprosthesis, the formation of extensive defects in the proximal part of the femur (greater and lesser trochanter), with perforation of the femur and loosening of the stem of the primary endoprosthesis, as well as bone cysts in the periacetabular area (without destabilisation). The cavities were filled with dark content (specific to metal abrasion products), indicating severe metallosis and the metal neck of the femoral stem was severely scratched. Intense contamination of the polyethylene surface of the insert of an unknown origin was also observed (Fig. 3,4). The elements of the primary endoprosthesis removed during the procedure were subjected to further macroscopic and microscopic examination.

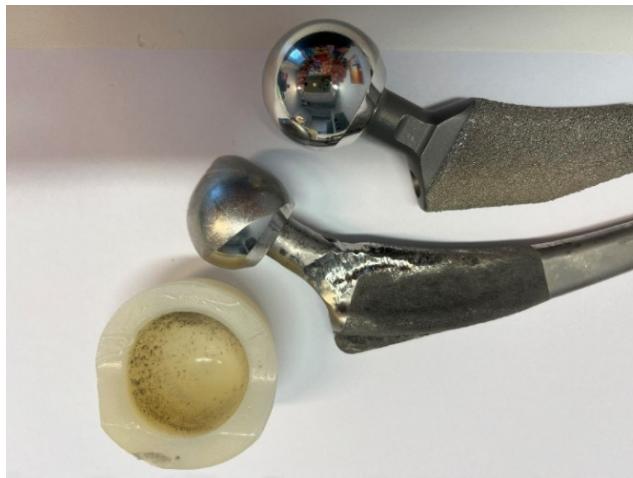
Figure 3. General view of the removed endoprosthesis elements compared with a new endoprosthesis of the exact dimensions

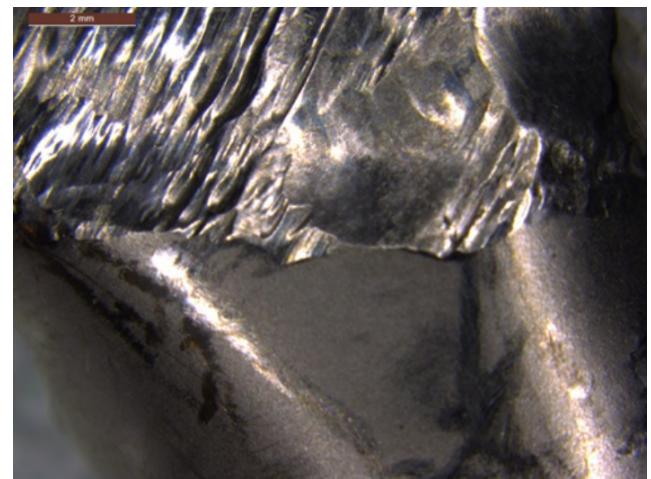
Figure 4. General view of surface damage on the neck of the endoprosthesis stem, stereoscopic microscopy

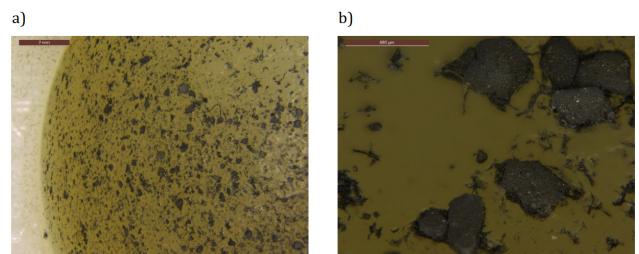
The macroscopic analysis revealed that the polyethylene surface was contaminated with particles of different sizes embedded in the endoprosthesis cup's sliding surface. A sample stereoscopic image of such particles is presented in [Figure 5](#). Observations at higher magnifications showed that their embedding in the surface was related to the for-

Figure 5. a) Stereoscopic view of the acetabular surface with numerous embedded foreign particles. b) Enlarged fragment of the area in Figure a. Visible particles of various sizes up to 0.5 mm with sharp edges embedded in the polyethylene insert surface. Locally observed surface cuts around these particles. Stereoscopic microscopy.

mation of numerous cuts in the polyethylene surface, which proves their deep anchoring in the polyethylene surface. A similar macroscopic image of ceramic particles embedded in the surface of the polyethylene insert, formed after the fracture of the ceramic head of the endoprosthesis, was observed by Kampf et al.²² And Hasegawa et al.²³ In the first case, this led to dramatic wear of the steelhead of the endoprosthesis, which corresponded to a weight loss of 48.1g in the form of outstanding steelwear products released into the surrounding tissues.²²

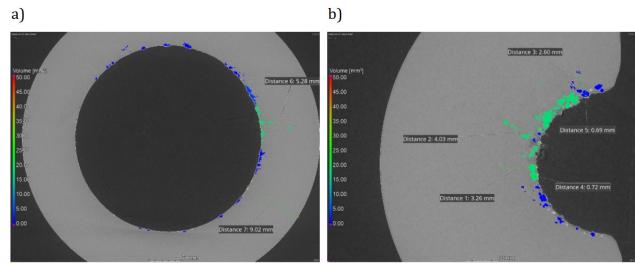
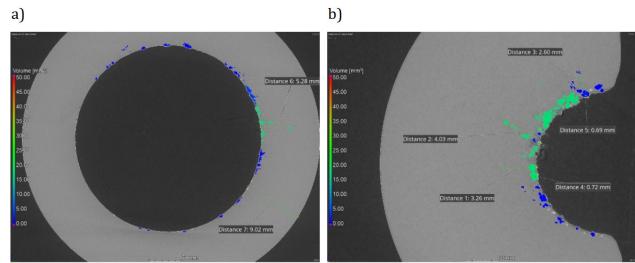
Based on observations of 3D and 2D computed tomography scans, it was found that the accumulation of particles was most significant in the upper part of the acetabulum (Fig. 6,7). The concern, in particular, is particles with a larger volume of approximately 15 to 20 mm³. Measurements taken in these areas at various cross-sections showed that some particles were as deep as 6.5 mm. In the near-surface areas, particles with smaller volumes of up to 10 mm³ were located. The size of selected larger particles located near the surface was estimated to be approximately 0.7 mm. Shen et al.²⁴ showed that the size of ceramic particles affects the loss of a ball made of stainless steel under friction conditions, and they observed the most significant wear in the case of large-sized particles.

Figure 7. 2D scan image in frontal (a) and lateral (b) plane

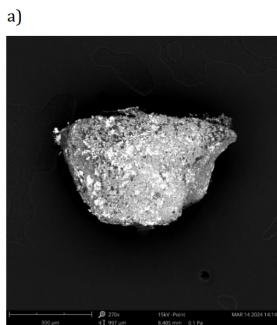
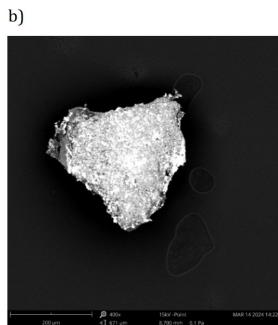
The presence of external third bodies inside the tribological system was confirmed by SEM/EDS analysis. A general view of sample particles isolated from the polyethylene surface is shown in Figure 8. The spectra of characteristic radiation obtained from both particles are presented in Figures 9 to 12. They showed heterogeneity of chemical composition resulting from mixing wear products, but the results were repeatable. EDX analyses showed that the aluminium and oxygen content in the particles were similar to Al₂O₃. In both studies, in which aluminium and oxygen were observed as the only elements, the composition is close to stoichiometric for corundum ceramics. Analyses performed on the first researched particles showed magnesium and elements typical of aluminium oxide. Bieniek¹⁷ points out that porous ceramics based on aluminium oxide also contain MgO and CaO.¹⁷ The presence of calcium was observed in analyses performed on the second tested particle, in which wear products of the head of the endoprosthesis made of the Co-Cr-Mo alloy were also found. It is worth paying attention to the relatively low cobalt content with a significant share of chromium and molybdenum. Koronfel et al.²⁹ emphasise the preferential dissolution of cobalt according to a mechanism similar to dealloying. This also explains the non-stoichiometric content of cobalt concerning other elements from the Co-Cr-Mo alloy during its degradation.

Figure 8. General view of sample particles isolated from the polyethylene surface

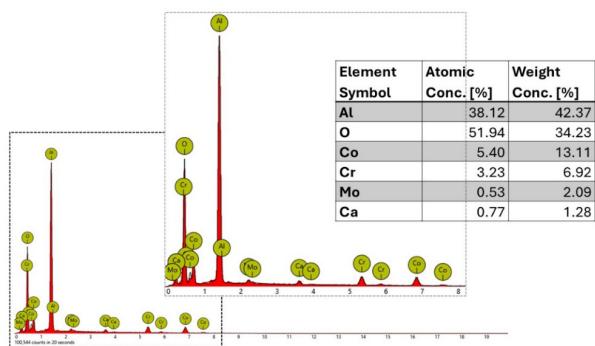
Figure 11. X-ray characteristic spectrum obtained from particle two at point 1 with results of EDX chemical composition microanalysis

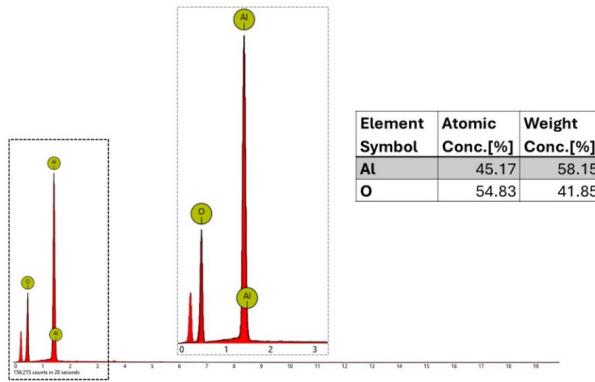
Figure 9. X-ray characteristic spectrum obtained from particle 1 at point 1 with results of EDX chemical composition microanalysis

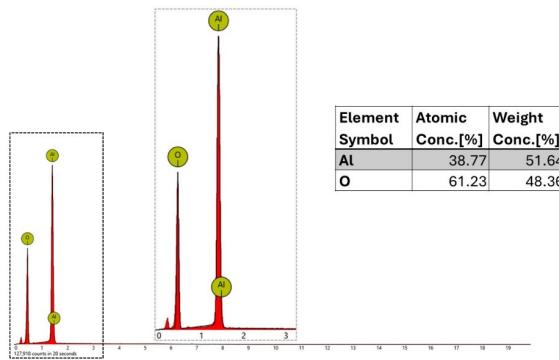
Figure 12. X-ray characteristic spectrum obtained from particle two at point 2 with results of EDX chemical composition microanalysis

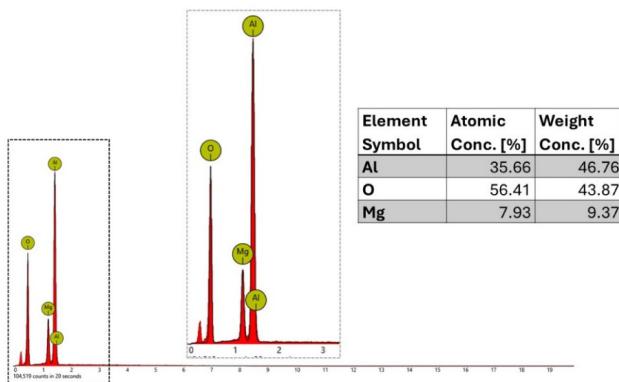
Figure 10. X-ray characteristic spectrum obtained from particle 1 at point 2 with results of EDX chemical composition microanalysis

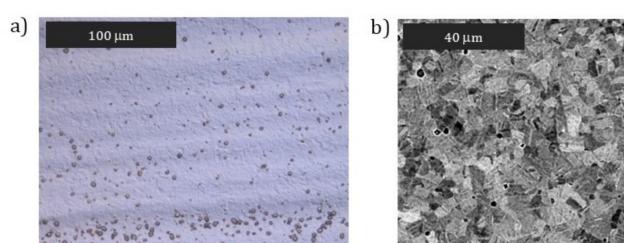
To exclude the influence of poor quality material used for the endoprosthesis head, metallographic tests were performed. The microstructure of the tested material was typical for wrought alloys. Excellent austenite grains with banded carbides were visible (Fig. 13). The high chromium

Figure 13. Microstructure of the CoCrMo material used for the endoprosthesis head: a) visible banded carbides typical of wrought alloys, light microscopy, b) visible refined austenite grains, SEM.

content favours the formation of mainly $M_{23}C_6$ type carbides, but chromium-rich can also be M_7C_3 and M_3C_2 type carbides.^{30,31} In the surface region, no changes in hardness were observed related to weakening or strengthening of the material due to deformation (Fig. 14). At the same time, the average hardness of the material was high and also typical for these alloys. No microstructural causes were found that could contribute to reduced abrasion resistance of the endoprosthesis head.^{32,33}

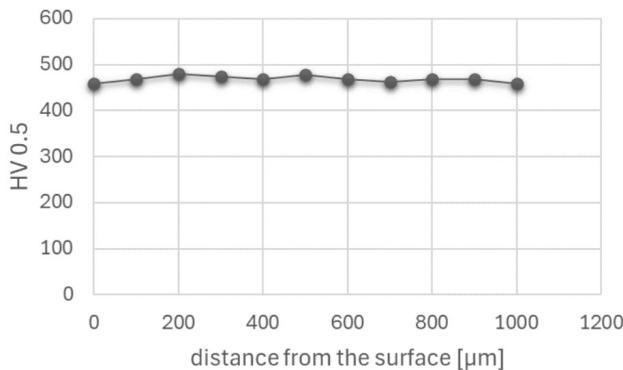
Figure 14. Hardness distribution performed on the cross-section of the endoprostheses head in the subsurface area

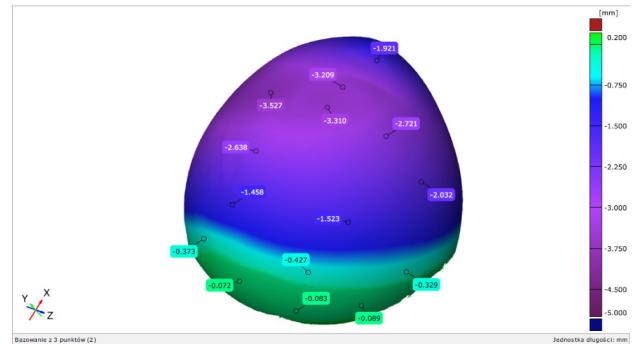
More information about quantitative analysis can be obtained from 3D measurements made using a 3D scanner, the results of which, in the form of a deviation map, are presented in Figures 15 and 16. 3D scanning is an advanced process that allows the transfer of an actual three-dimensional shape into a digital form. The study compared the tested post-exploitation endoprostheses with a new endoprostheses head with the same geometry. This allowed for determining material loss by finding the difference in geometric dimensions. In this study, the damage of a Co-Cr-Mo alloy ball was associated with the value of $K=(R-r)$, where R and r are the radii of the unused head and the head with a worn surface, respectively. The analysis of the scanning results shows that the K parameter characterising the material loss exceeded 3 mm in many places. The most considerable losses were observed on the top of the head. This is the place with the most significant accumulation of ceramic particles embedded in the polyethylene surface. The lower area of the head, which did not cooperate with the acetabular cup, did not show any material loss, confirmed by macroscopic observations. The differences that exist are solely due to the tolerance of the element.

Figure 15. 3D scanning measurements in the form of a deviation map in the Z plane

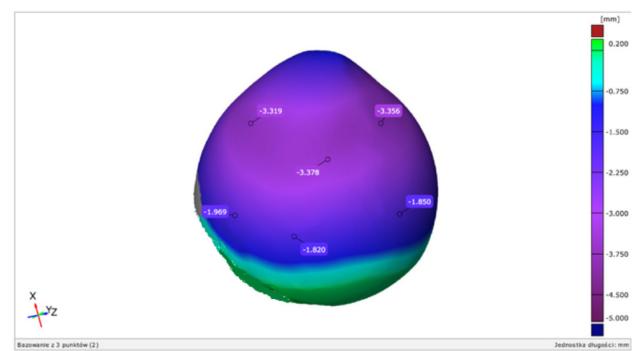
Figure 16. 3D scanning measurements in the form of a deviation map in the Y plane

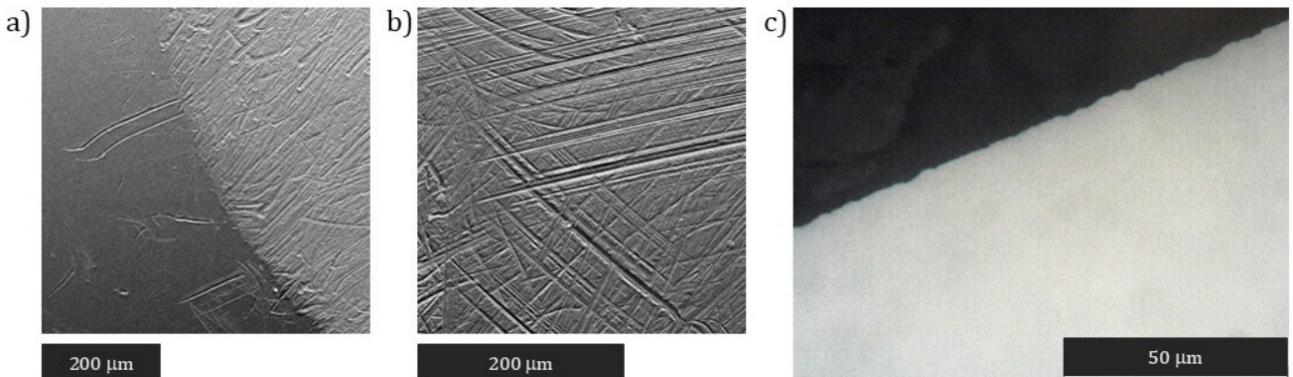
The microscopic observations of the head surface of the endoprostheses made of the CoCrMo alloy indicate that the worn head surface showed typical features of abrasive wear (Fig. 17). The relatively deep abrasive grooves near the edges of the worn surface can be observed in the low magnification of the SEM images. Microploaching is the dominant erosion mechanism caused by hard third-body particles, in which the material is not removed from the surface but moves to the side of the erosion groove.⁴⁰ However, macroscopically, the wear features showed different dam-

Figure 17. a) Surface morphology of the endoprosthetic head in and outside the area of the contact with the acetabulum, SEM; b) Enlarged fragment of the area from Figure 17a, SEM, c) cross-section through the endoprosthetic head with visible surface grooves, light microscopy

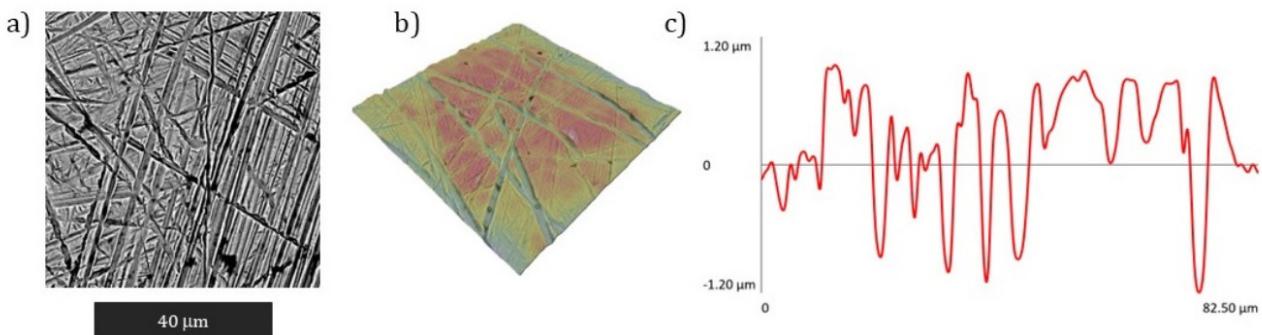
Figure 18. a) Morphology of the endoprosthetic head surface, SEM; b) 3D profile of the endoprosthetic head surface with marked profile lines, c) roughness profile obtained along one of the example lines shown in 18b: Rz: 1.59 μm, Ra: 452 nm

age characteristics due to differences in the local contact pressure. The extent and shapes of the wear grooves indicate a significant difference in the movements and size of the abrasive particle.^{41,42} Those detached particles could form third bodies and be rejected from the contact or spread on the metal surface. Topographic measurements were used to describe wear. Analyses performed on the surface, shown in [Figure 18](#), indicate that the depth of these scratches was up to approximately 2 μm. A representative measurement taken along one of the lines is shown in [Figure 18c](#).
