# Correction: Biomechanical comparison of single versus double plate osteosynthesis in acromion type III fractures

This is a corrigendum to <https://doi.org/10.52965/001c.88396>

## Orthopedic Reviews

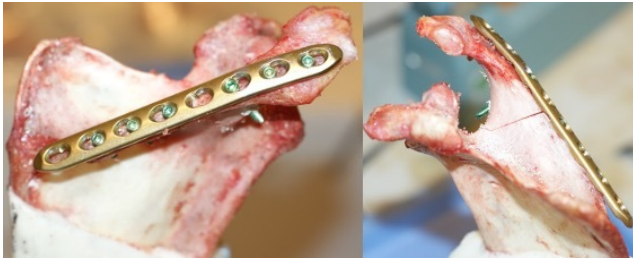
**Fig. 1. Right scapula with acromion type III fracture with a single-plate osteosynthesis**

All surgeries were performed by a senior author. A type III acromion fracture according to Levy et al.'s classification was made with a saw. After fracture simulation, the specimens were randomized into two groups. In the first group, single-plate osteosynthesis using a locking plate was performed. Therefore, an eight-hole 3.5-mm locking compression plate (Depuy Synthes, Raynham, MA, USA) was used. The plate was adapted to the curvature of the scapular spine/acromion and placed on top of it. Always three screw holes, each medial and lateral to the fracture, were filled with locking screws after length measurement. The screws were tightened with an appropriate torque wrench (Fig. 1). In the second group, double-plate osteosynthesis was performed. The first plate was placed and fixed in the same manner as the single plate in the first group. The second plate was placed inferiorly from the scapular spine and perpendicular to the first plate. The second plate was a 3.5-mm one-third tubular locking plate (Depuy Synthes, Raynham, MA, USA). After drilling, three screws were placed medial and lateral to the fracture. The screws were tightened with a torque wrench (Fig. 2).

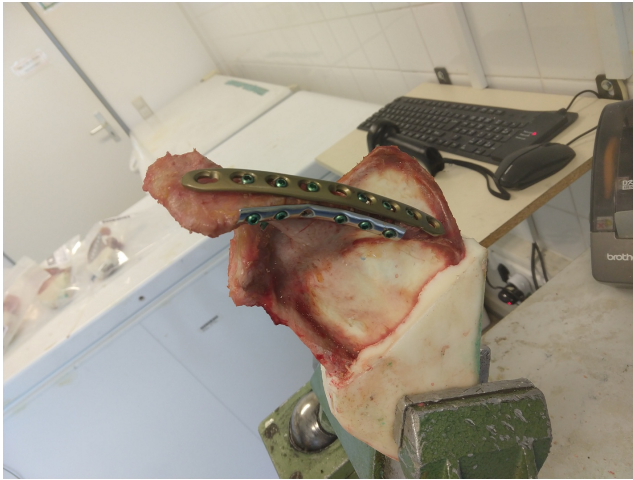
**Fig. 2. Left shoulder with acromion type III fracture with a double-plate osteosynthesis**

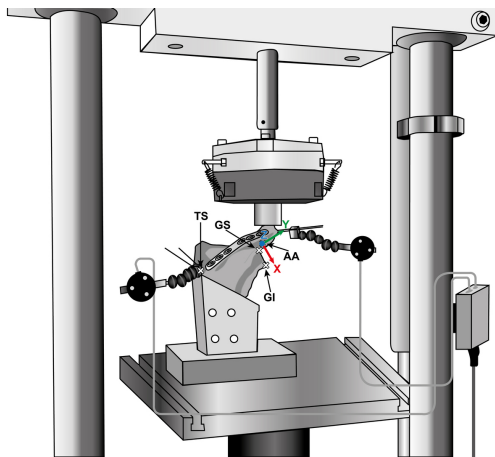
**Fig. 3. Right shoulder with a single plate osteosynthesis mounted in the testing setup (GS: glenoid superior, GI: glenoid inferior; TS: trigonum scapulae; AA: acromion angle)**

The human cadaveric scapulae were thawed to room temperature and completely freed from soft tissue. The lower part was embedded in cold curing casting resin (RenCast® FC 52/53 Isocyanate, FC 53 Polyol, and Füller DT 982, Gößl & Pfaff GmbH, Karlskron/Braunlach, Germany) using a custom-made box. During the surgery and biomechanical testing, the specimens were soaked with 0.9% NaCl (Fig. 3).

produced, which had no contact with the plates. Force was directly applied on the superior surface of the acromion (Fig. 3). The preloading force was set at 30 N. This protocol was similar to that of Kicinski et al.<sup>28</sup> The failure of the osteosynthesis was defined as abrupt loss of load, and the ma-

During biomechanical testing, the stiffness and translation were measured with an optical tracking system (Optotrak Certus, NDI, Waterloo, Canada), that is, the resulting three-dimensional translation of the acromion relative to the scapular spine. The 3D accuracy of the optical tracking system was 0.1 mm, and the resolution was 0.01 mm. Optical tracking markers were placed on the acromion and the other on the scapular spine. The three-dimensional coordinate system of the optical measurement was defined by tracking four bony landmarks (acromial angle, trigonum scapulae, superior glenoid, and inferior glenoid). The coordinate system was defined with the x-axis pointing inferior (superior glenoid to inferior glenoid), the z-axis pointing lateral (trigonum scapulae to acromial angle), and the y-axis perpendicular to the x-z plane pointing anterior. The origin was placed on the acromial angle. Because the angulus inferior was not accessible, the coordinate system was adapted to the recommendations of the ISB<sup>30(p200)</sup> (Fig. 3). The stiffness was defined as force per distance (N/mm).

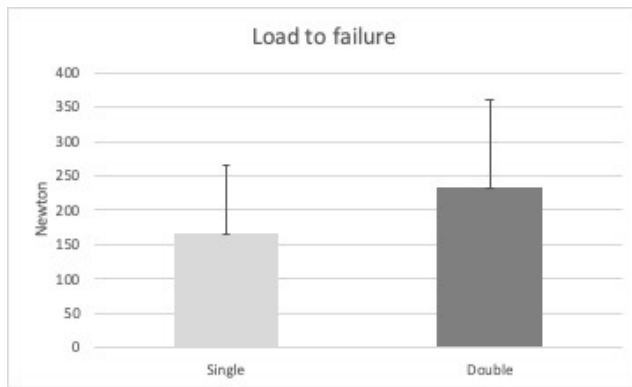
**Fig. 4. Comparison of load at failure between single- and double-plate osteosyntheses**

The average load at failure was 167 N (SD 99.2) in the single-plate osteosynthesis group and 233.7 N (SD 127.7) in the double-plate osteosynthesis group. This difference was not statistically significant ( $P = 0.328$ ) (Fig. 4). The average translation was 11.1 mm (SD 5.8) in the single-plate osteosynthesis group and 16.4 mm (SD 17.2) in the double-plate osteosynthesis group, but the difference was not significant ( $P = 0.753$ ) (Fig. 5). The difference in stiffness between the two groups was 253.2. The mean stiffness was 74.7 N/mm (SD 69.2) in the single-plate osteosynthesis group and 327.9 N/mm (SD 394.3) in the double-plate osteosynthesis group, but the difference was not significant ( $P = 0.141$ ) (Fig. 6). In the first group, the screws on the spina scapula broke out of the bone medial to the fracture in six cases and in one case lateral to the fracture. In one case the spina scapulae showed a splinter fracture. In the double-plate osteosynthesis group, the failure of the osteosynthesis with breaking out of screw medial to fracture in six cases. In one case the scapula showed fracture, which went to the spina scapula. An acromion fracture was observed in one case.

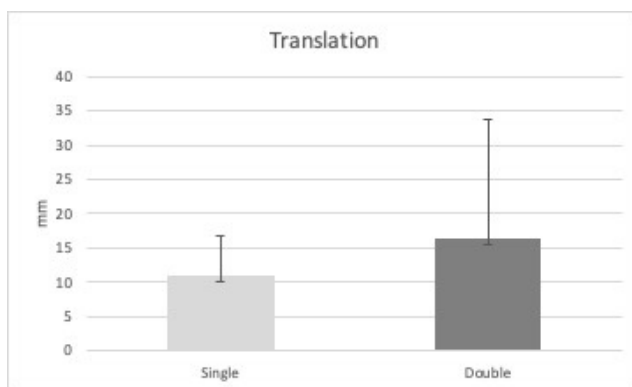
**Fig. 5. Comparison of translation between single- and double-plate osteosyntheses**

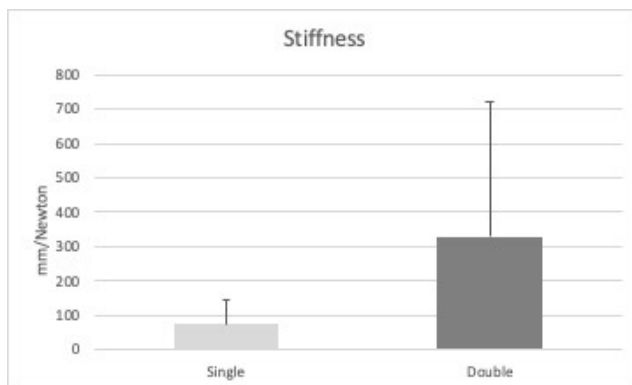
**Fig. 6. Comparison of stiffness between single- and double-plate osteosyntheses**
